digital	FIELD SERVICE TECHNICAL MANUAL				Option or Designator
	12 Bit <input checked="" type="checkbox"/>	16 Bit <input checked="" type="checkbox"/>	18 Bit <input type="checkbox"/>	36 Bit <input type="checkbox"/>	AD01

Title AD01 MULTIPLEXER F.E.T. Leakage				Tech Tip Number AD01-TT-1	
All Processor Applicability			Author R. Adams		Rev 0
8's	11's		Approval J. Blundell	Date 12/07/72	Cross Reference

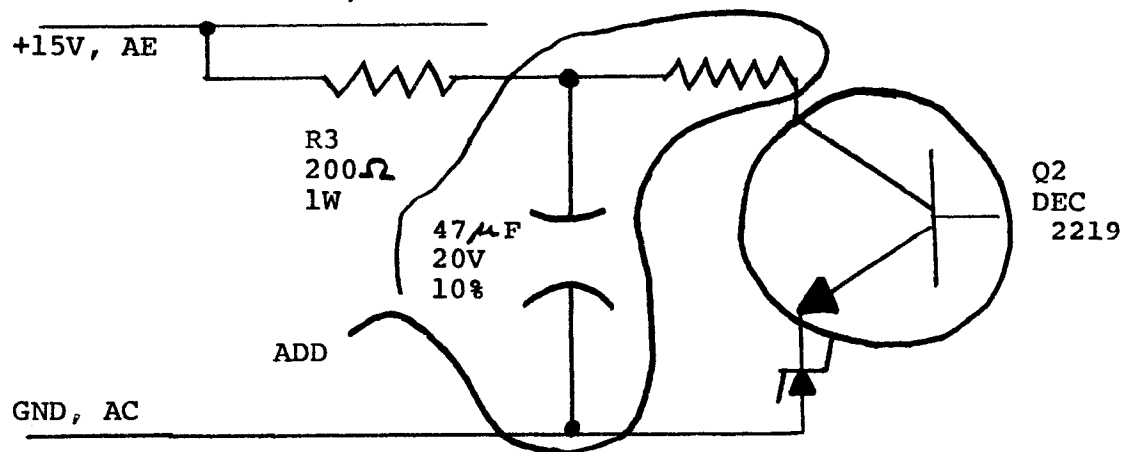
Problem: AD01A A/D converters that have AH04 and AH05 (Sample/Hold and Sign bit bipolar) options installed have been exhibiting a power supply problem. The problem is seen when more than three (3) A124 modules (12 channels) are installed. The symptoms are that the positive 15 volt drops to 8 - 10 volts. This drop in the +15 volt line also causes the +5 to drop and the -15 likewise.

Cause: The cause of this problem is the use of the Deltron P/N 12-03185-3 Power Supply, which during power up, becomes overloaded and due to its inherent characteristics cannot recover from the overload condition.

Correction: An ECO A708-0003 adds a 47 ufd cap. 20V 10% and a 97-Ω ½W resistor from collector of Q2 a DEC 2219 transistor to GND, AC.
