digital	FIELD SERVICE TECHNICAL MANUAL				Option or Designator
	12 Bit <input checked="" type="checkbox"/>	16 Bit <input checked="" type="checkbox"/>	18 Bit <input type="checkbox"/>	36 Bit <input type="checkbox"/>	AD01

Title AD01 MULTIPLEXER F.E.T. Leakage				Tech Tip Number AD01-TT-1	
All Processor Applicability			Author R. Adams		Rev 0
8's	11's		Approval J. Blundell	Date 12/07/72	Cross Reference

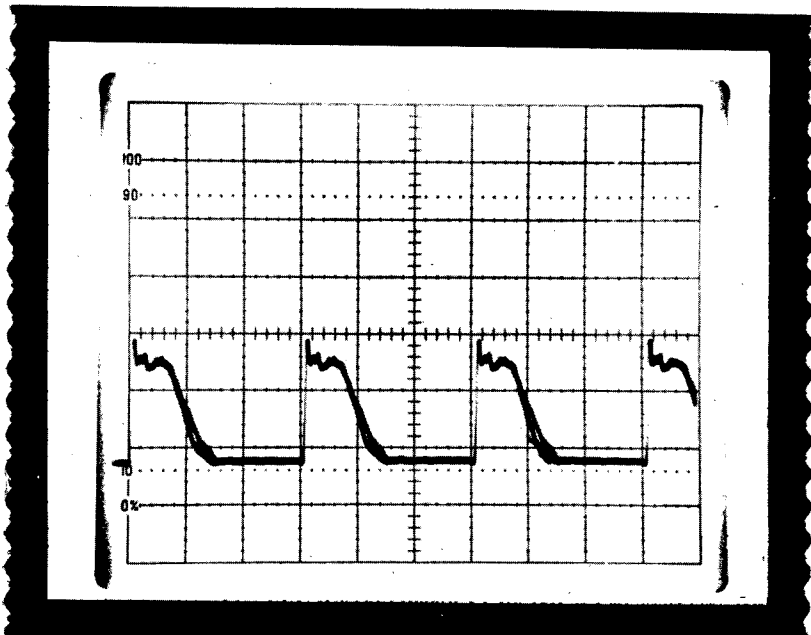
FIGURE 8

7. Observe Jack 7, again while depressing write 2, the output should resemble Figure #8, leading edge to leading edge should be approximately 600 nsec. Figure #8 represents 200 nsec per CM if adjustment is necessary, go to 7A.

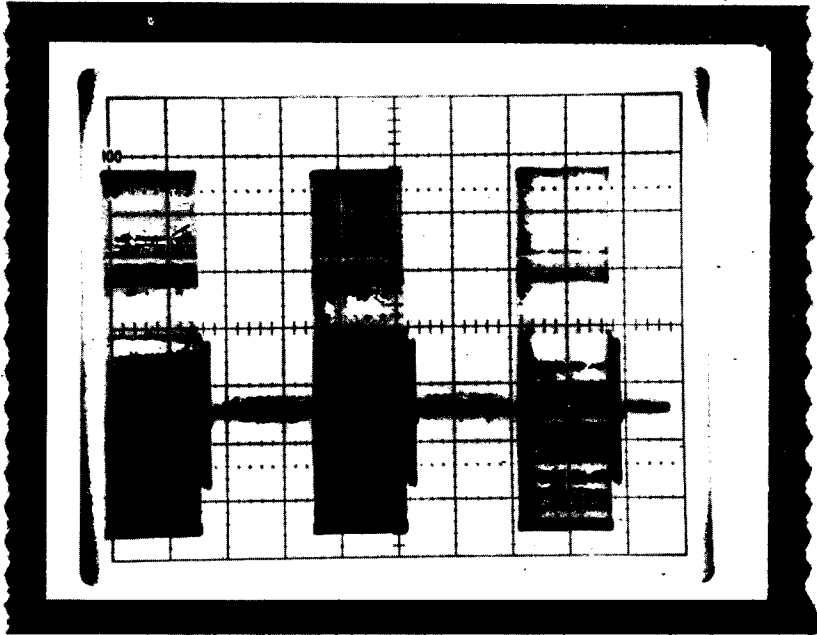
Figure 9
Time/Div = 20 Msec

4. Depress write 2 and observe scope. Display should resemble Figure #9. (This shows that both the write and the erase cycles are occurring). If the display does not resemble Figure #9 and the cycle is a continuous write, an internal noise problem exists. Refer to (Synopsis of Error and Correction Lists).

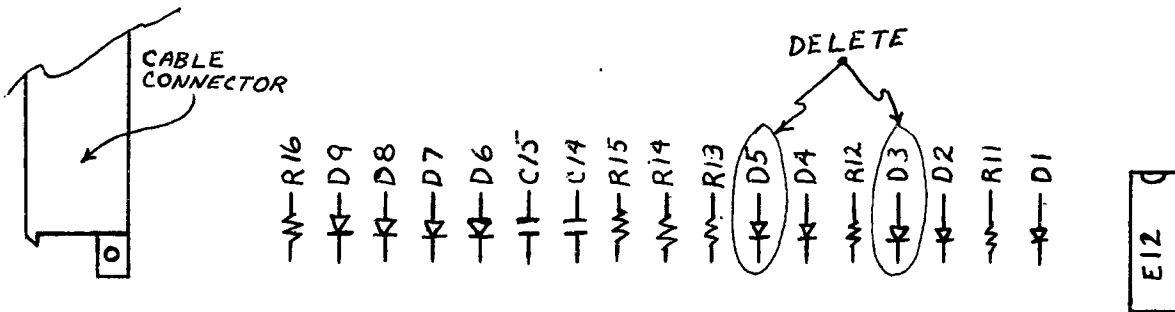
The only modification that is required to the module is to delete two diodes (D3 and D5). These diodes are located in the upper left hand part of the module as shown in the picture below.

With these two diodes removed the DK8E clock diagnostics (Maindec-8E-D8AB-D-(D)) will not run. To have an operative diagnostic two locations will have to be changed. They are:

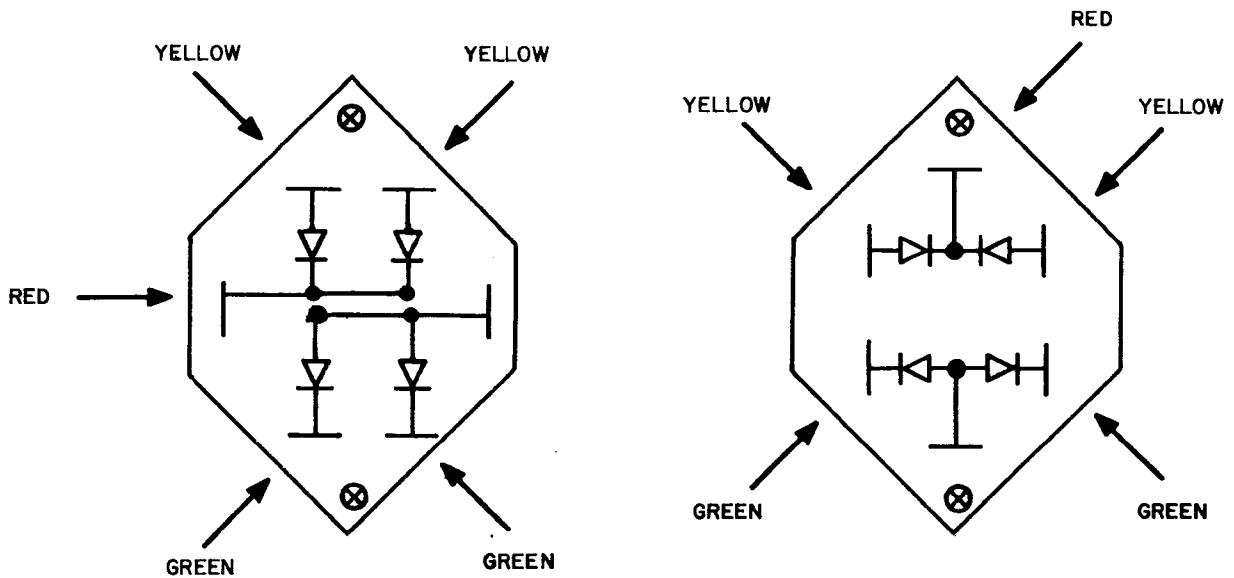
Some confusion has arisen from the fact that DM-1 rectifier packages produced by Solatron have their physical terminal configuration shifted 90° with respect to those manufactured by Motorola. All internal connections, color coding, and electrical characteristics are identical for both units.

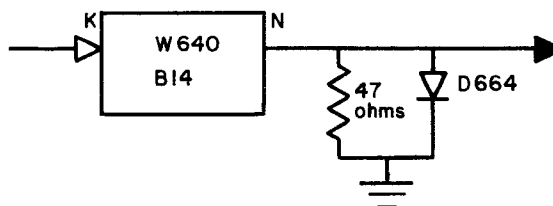
Print D-BS-637-0-1 (at B8) indicates a diode, resistor network to ground.

If the network has not been installed, random data errors can occur which will not be detected by the off-line diagnostics 08-D8HB, LA, FA or NA. If the diode has been installed with its polarity reversed, all data will be incorrect, shifted left some indefinite number of bits (one or more).

The on-line Maindecs 08-D8EB and KA may not detect the absence of these components but will fail if the polarity of the diode has been reversed upon installation.

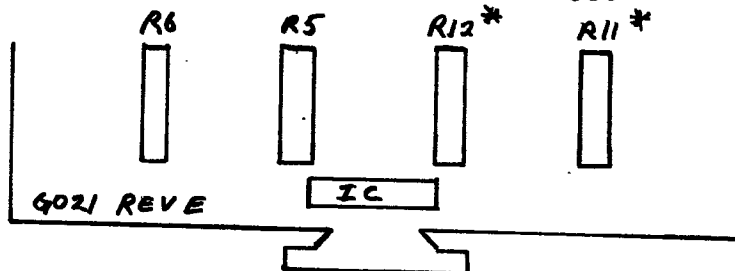
- 1) Rev. D and earlier are considered -3V slice level.
- 2) Rev. F and later are considered -4V slice level.
- 3) Rev. E can be either -3V or -4V and it is the only revision that can be changed. The resistors to change are listed below:

R6	R5	R12	R11
-3V slice level	300	330	330	300
-4V slice level	330	180	180	330

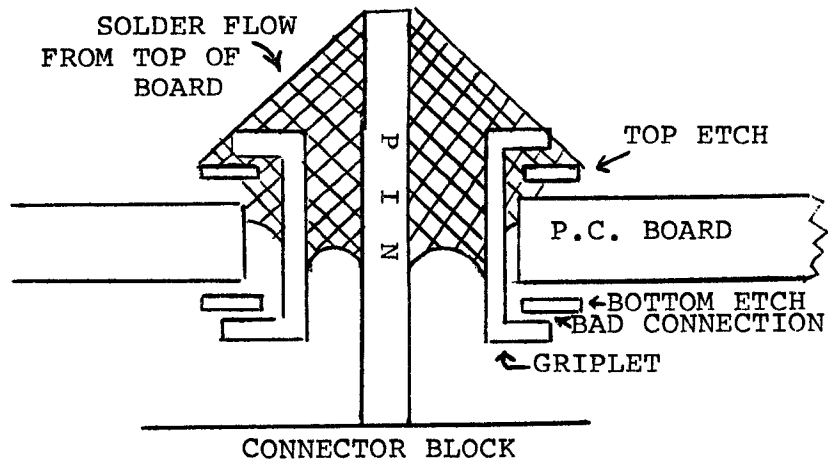
For a period the 50-08903 board used on the H851 over the top connector was manufactured using griplets to make the connection through the board. The griplet process can result in bad connections (anything from five (5) OHMs to open circuit), and was ECO'd out of the H851 manufacturing procedure as from September 1, 1972.

The only methods of checking are careful visual inspection under the board, using a solder sucker to clear a hole for inspection or OHM meter checking.

Also, an unknown number of connectors were assembled with the board on backwards. This gives no electrical problem, but could be confusing if you are counting pins for scoping and rely on the "A" etched on the board to find pin A. It could be pin V.

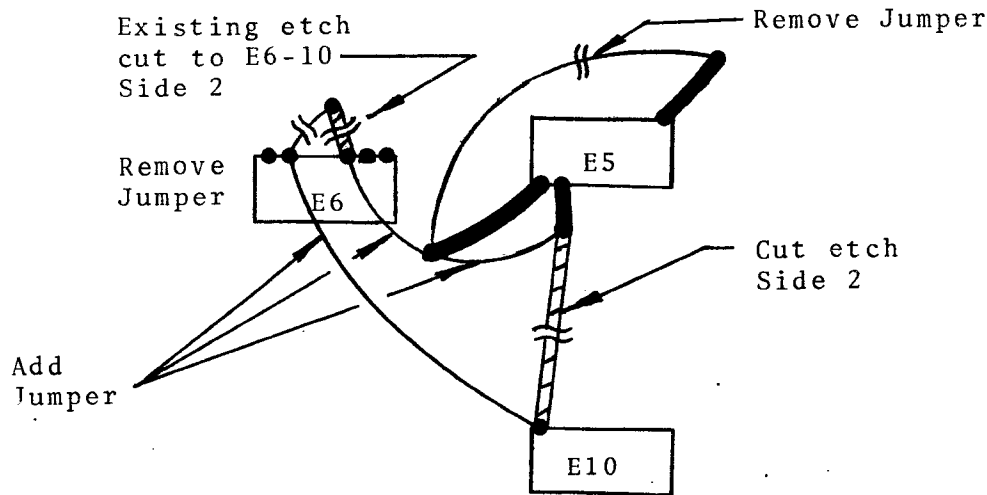
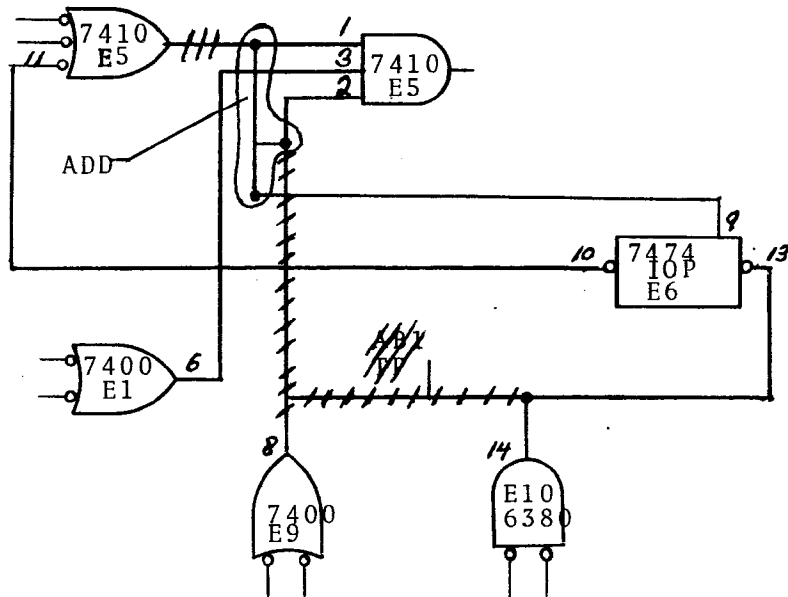
ECO M835-00003 is in error. A new ECO #M835-0004 has been generated to correct. The following sketches are correct.

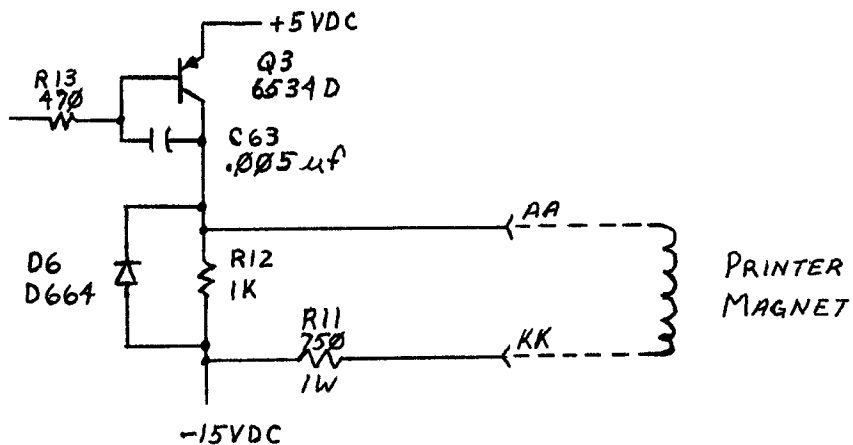
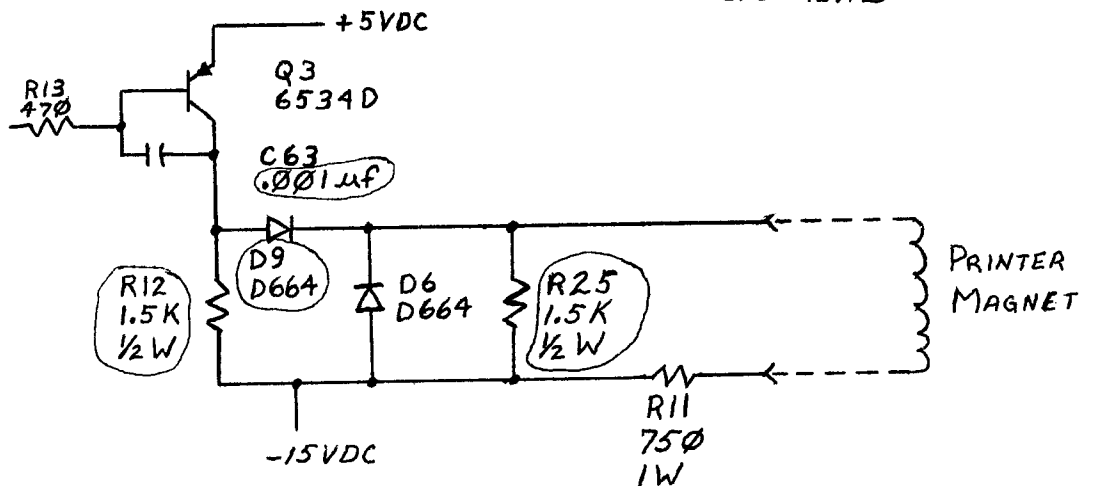
C.S. REV. A
C.S. REV. B

Some M8650, C.S. Rev. A prints were shipped without the hand made change added to the circuit which would make them C.S. Rev. B. The change to the circuit is shown below.

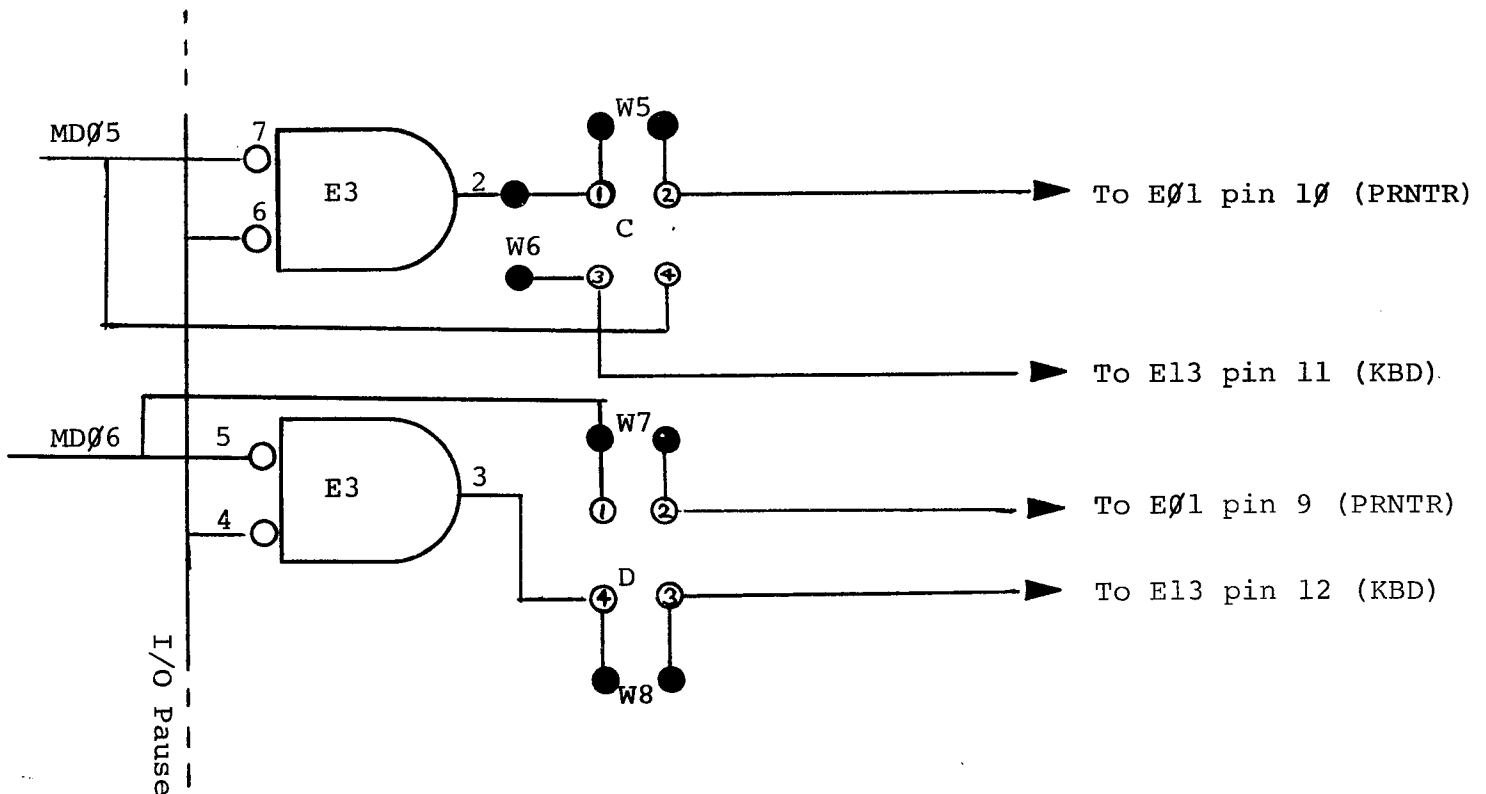
The fault symptom will typically be either wrong sense of bits 5 or 6 in the decoded IOT, or MD bit 6 always constant on the omnibus.

The same mistakes have been carried over into the LS8E (M8342) control. The drawing below also applies exactly to the C.S.Rev.0 of that board.

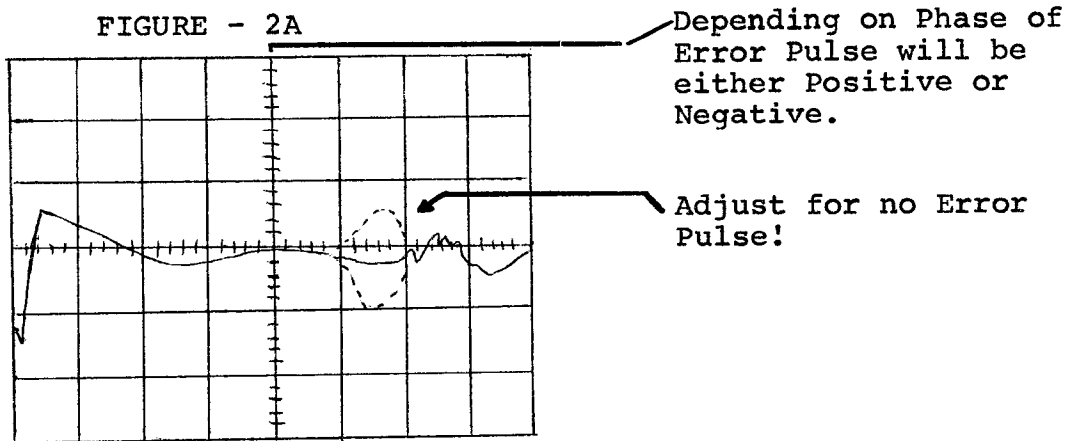
- 4) The wave form seen is the negative portion of a 65V negative pulse.
- 5) Now reset scope to ADD channel B INVERTED. The waveform now seen should resemble the waveform shown below. The dotted area drawn indicates the error and should be adjusted out by turning appropriate allen screw adjustment.

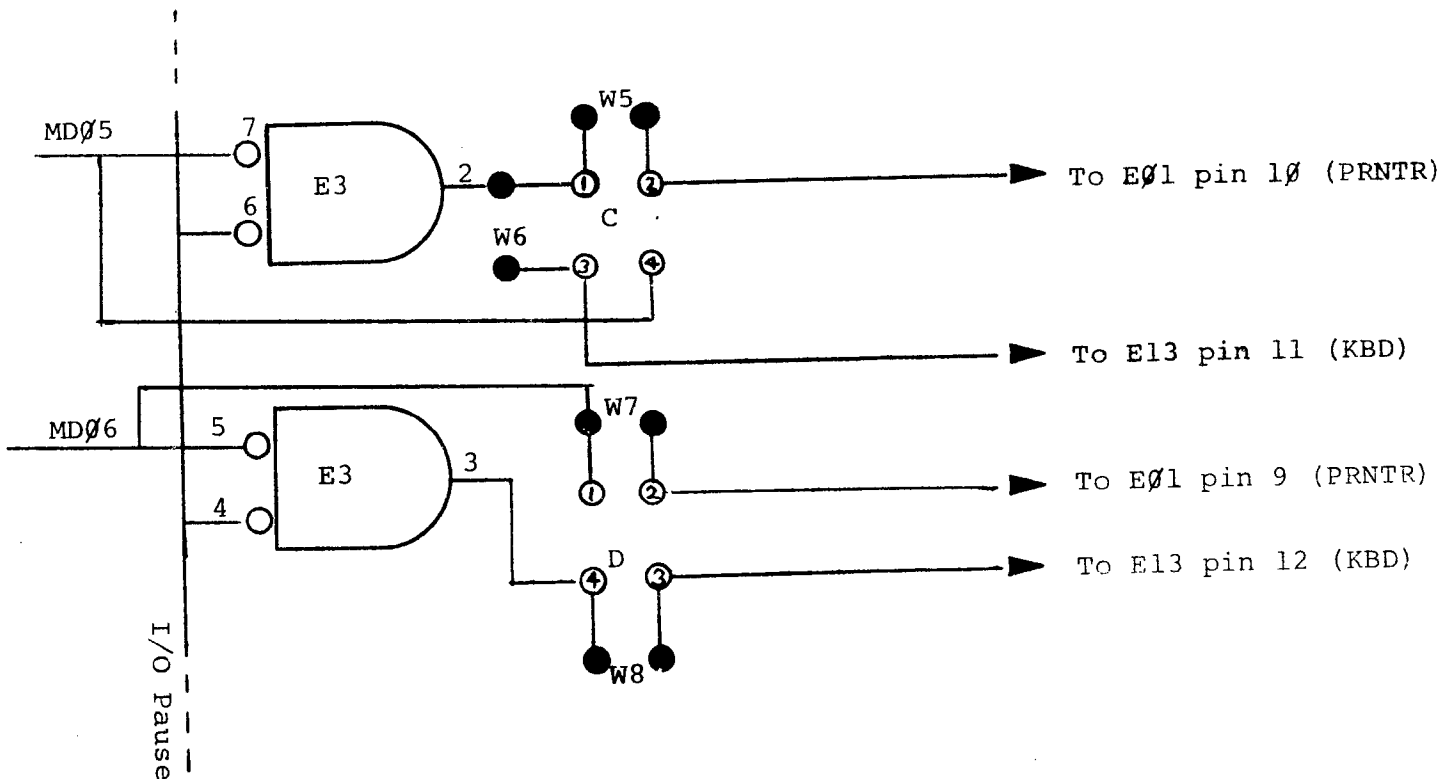
The fault symptom will typically be either wrong sense of bits 5 or 6 in the decoded IOT, or MD bit 6 always constant on the omnibus.

The same mistakes have been carried over into the LS8E (M8342) control. The drawing below also applies exactly to the C.S. Rev. 0 of that board.

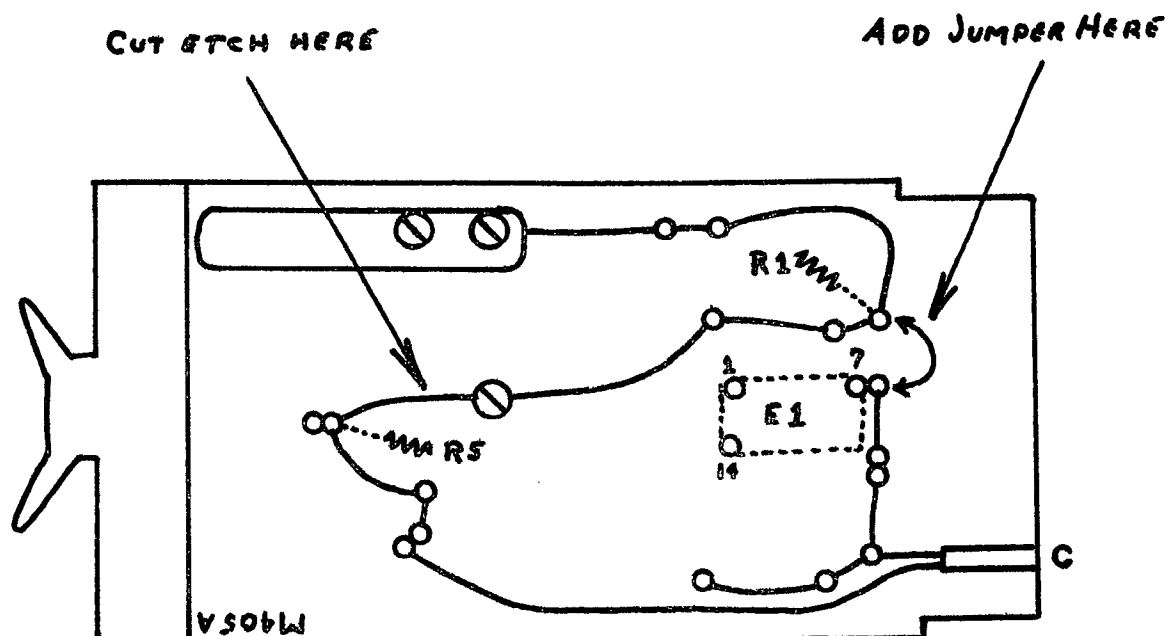
The M405A Crystal clock has been known to produce a multiple pulse output when operating in the 5-10 and 19-20 KHZ ranges. If you experience this problem, replace M405A with M405B, which incorporates ECO M405-01. This ECO isolates the analog circuitry ground from the tank circuitry ground, and both widens and shortens the tank ground path to reduce inductance, thereby eliminating the problem.

The accompanying sketch illustrates the ground path and the alteration points.

If an M405B is not available you may install the ECO yourself as follows: Looking at the etch side of the M405A (Handle **UP**), cut the etch between the bottom left shield screw and R5. Solder a piece of insulated wire from Pin 7 of E1 to the ground side of R1.

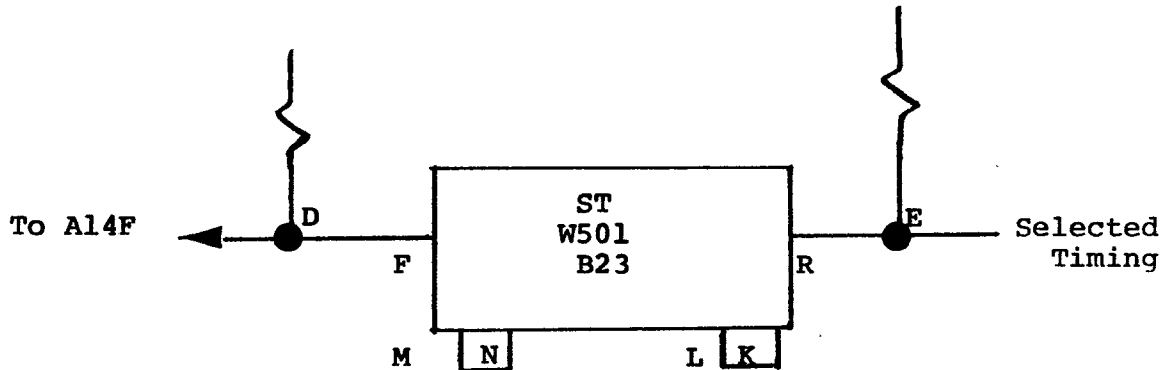
Reference print PA60-A-4 circuit changed as follows:

The W501 Schmitt trigger (B32) might not be operating properly. The output pulses may vary radically in width and frequency with the punch running constantly. The problem may be that pin R, the input is clamped to about 2½ to 2½ volts. The problem can be solved by taking the 2 ma. clamp load (Pin D) off the input (Pin R), and the 10 ma clamp off the output (Pin F) and switching them. This results in having the input clamped with 10 ma clamp load, and the output clamped with the 2 ma clamp load. This causes the input to go to -3V and, as a result, reliable operations of the W501.

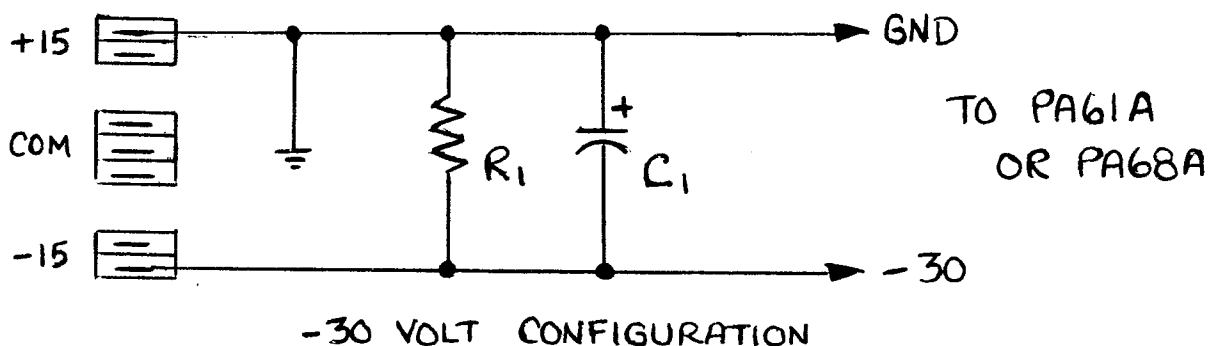
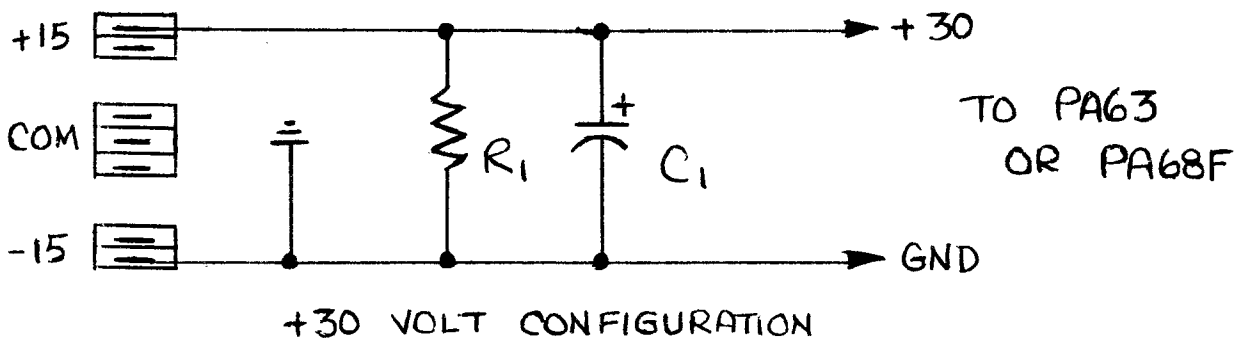
FIG. 1 - G799* POWER SUPPLY

There are two problems associated with the 30 volt power supply used on all typesetting systems. This is the G799 power supply (G799A for 240V/50 HZ) which supplies -30 volts for the PA61A and PA68A, and +30 volts for the PA63 and PA68F controls. The absence of a bleeder resistor on the 30 volt line has caused reader modules to be blown when inserting or removing the reader cable even with all power turned off. The other problem is excessive noise on the line when both the reader and punch are operating, causing various intermittent problems.

Both of these problems were solved by ECO number PA61-A-00003, but most units shipped to date have not had this change incorporated. The ECO consists of addition of a 500 ohm/25 watt bleeder resistor and a 50 mfd/50 volt bypass capacitor in parallel across the 30 volt output. This change applies to all controls (PA61A, PA68A, PA63, PA68F) and must be added if not already present to expect proper operation. See Figure 1 for correct wiring and parts numbers.

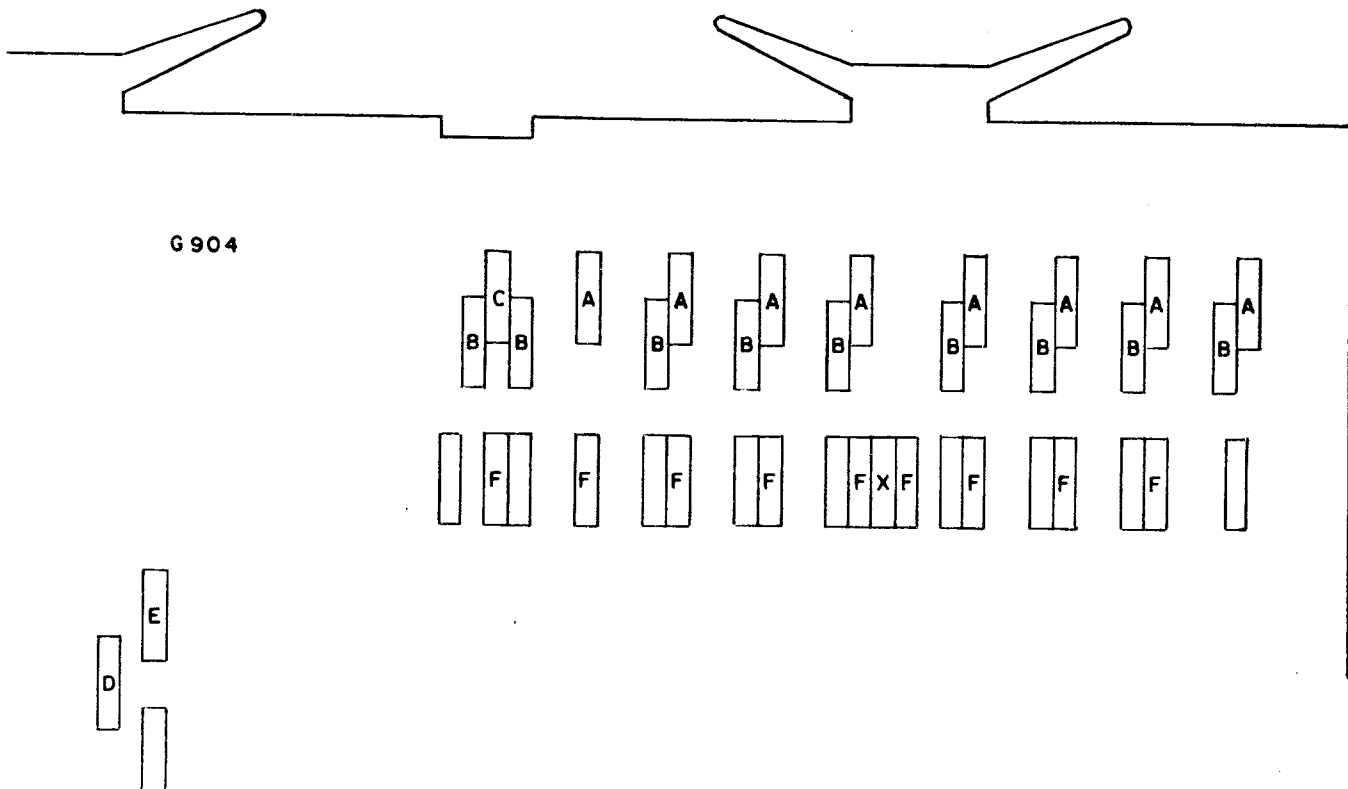
If a PC02 is found to be difficult to adjust, it may be that the G904 Photo Amplifier has not been modified. The modification is as follows:

1. Change eight (8) 12K ohm resistors ("A" in drawing below) to 100K ohm, 1/4 W, 5% (DEC Part #13-2466).
2. Change nine (9) 3K and 1K ohm resistors (B) to 100 UF capacitors (DEC #10-00016).
3. Change 3.9K ohm (or may be 7.5K) resistor (C) to 27K ohm, 1/4W (DEC #13-5346).
4. Replace the 2.2K ohm resistor (D) with a jumper wire.
5. Replace the ZENER diode (E) with a 1N750A ZENER (DEC #11-00124).
6. Remove nine (9) .01UF capacitors (F) from the card; there should be only one (1) .01UF remaining on the card, (X).

NOTE: The G9-4 should be adjusted for a 50/50 duty cycle using an alternate ones/zeros tape.

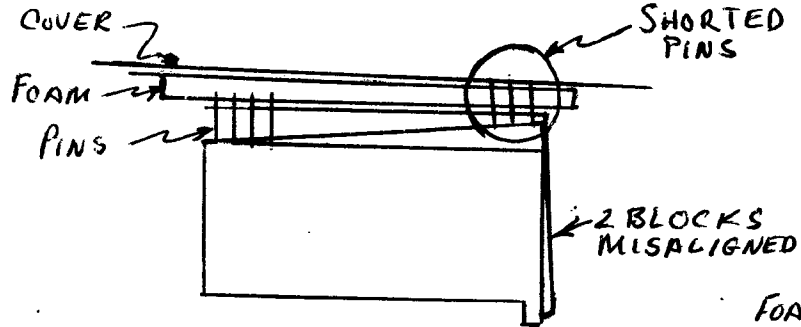
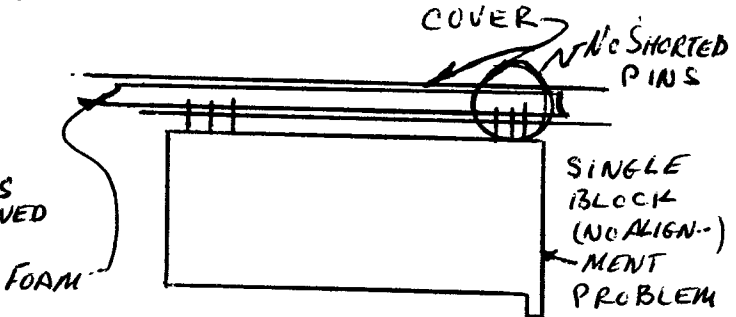
EDGE CONNECTOR (H851) MISALIGNMENT

On some of the old, double molded block, H851 connectors an alignment problem in manufacturing existed. Manufacturing now uses a single-molded block with two entry rows. The alignment problem no longer exists. Misalignment sometimes caused the H851 pins to push through the foam and short to the 8E cover.

In the event of this problem in the field, new H851's can be obtained from Maynard stock. Reference this tech tip and ask for the new single molded block, type.

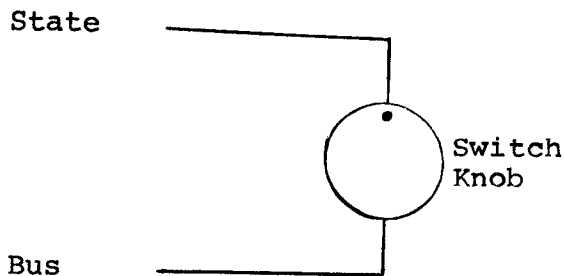
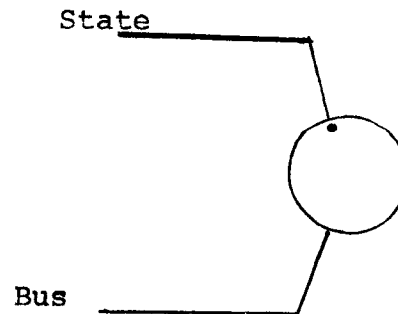
The two switches travel a different number of degrees between detents (old switch was a 36 degrees/click, new switch is 30 degrees/click) so a new console panel (plexiglass) is also required. The new panel, created by ECO 7408244-03, can be recognized easily by looking at the "State" and "Bus" reference lines. (See drawing below) it will also be date coded later than 15 June 1973.

Note That these ECO's are not for field retrofit. They are manufacturing changes only, and the purpose of this tech tip is to warn the field of a possible logistic/compatibility problem as the newer panels start to appear from production.

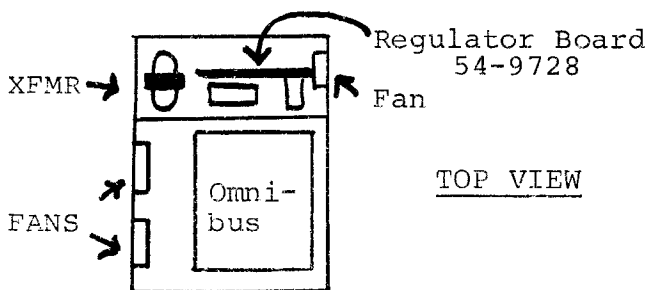
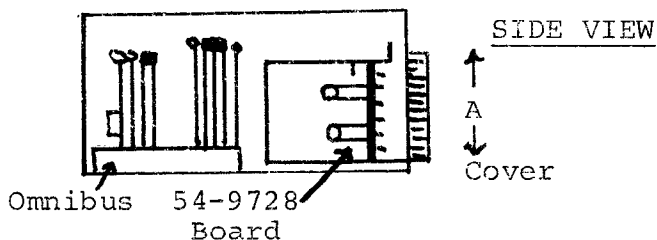
Title				FIT OF REGULATOR BOARD IN NEW 8M/8F CHASSIS		Tech Tip Number		PDP8M-TT-6	
All	Processor Applicability				Author	Jeff Blundell	Rev	0	Cross Reference
	8M	8F			Approval	Frank Purcell	Date	03/28/73

However, there is one problem you should be aware of. When the 54-9728 regulator board is manufactured it starts life as a board measuring approximately 6½" X 12". This should be eventually trimmed to its final size of 5.05" X 10.5", thus removing the crop marks on the etch. You will find many of the boards in your spares are oversize, with the crop marks still visible at the corners, and these will not fit in the new chassis, as dimension 'A' in the drawing will not tolerate a board wider than about 5.10.

Customers will not be impressed if you have to file or hacksaw a new board to fit in their machines, so check your boards carefully and trim them in the office before calling on a customer with power problems in a new style 8M or 8F.

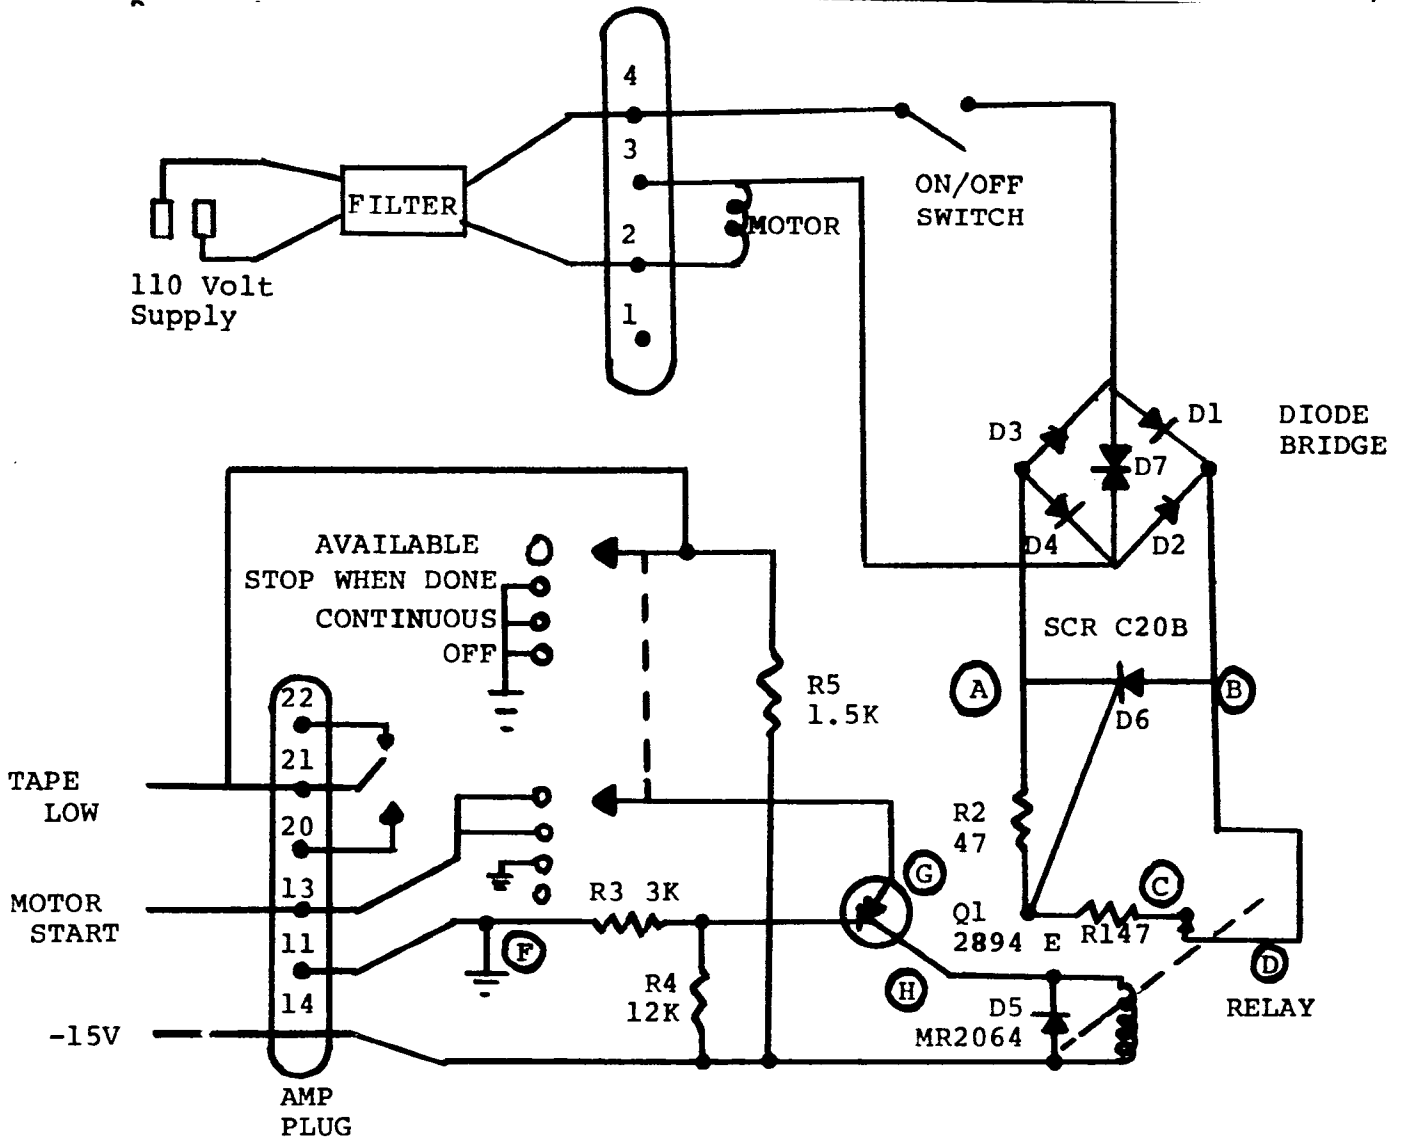
FIGURE 1

One other problem found in the punch control circuit is resistors R₁ and R₂ (47 ohm) burnt. This was caused by the SCR having an open cathode. When the relay contact closed, 110 volts is dropped across R₁ and R₂ and if SCR fails to fire, R₁ and R₂ will burn up.

For replacement part numbers for any of the above mentioned items, refer to punch control circuit schematics D-CS-7005095-0-1, Revision A.

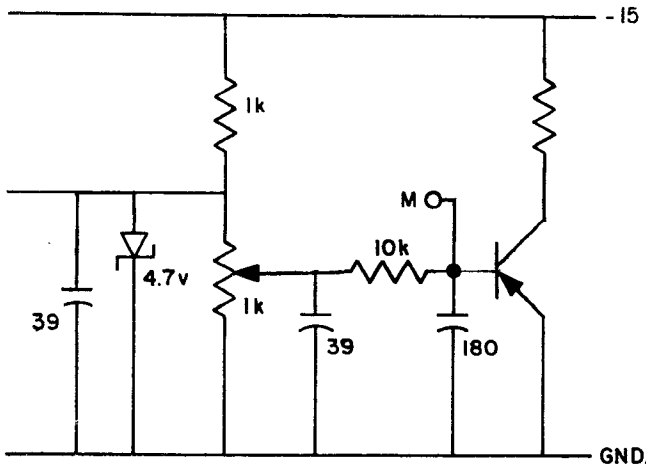
CORRECT CIRCUIT

Revision C boards, and some revision B, have a basic defect in that the trim pot is wired into the circuit incorrectly. These problems were identified by Tom Gibson and Norm Howe and are detailed in the schematic below.

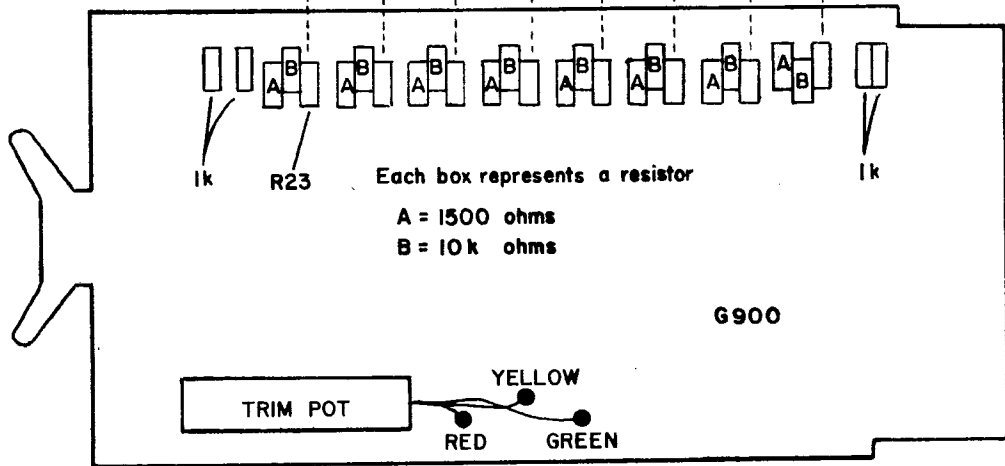
FIGURE 3

- Revision A - All bias resistors 10K ohms.
- B - All bias resistors changed except R23 at input pin U. Some defective because of trim pot miswiring (see over).
- C - All were defective - trim pot miswired - can be reworked as detailed on previous page)
- D - Correction to revision C but made improperly - not released.
- E - Revision D corrected - R23 still 10K.
- F - All known problems corrected - R23 changed to 15K.

Revision B boards can be repaired by simply connecting the trim pot leads to the proper split lug (see Fig. 3 next page).

Revision F boards will be released shortly and will incorporate the final scheme of compensating bias resistors. The resistor scheme (which is shown above) should be implemented in the field on all older boards.

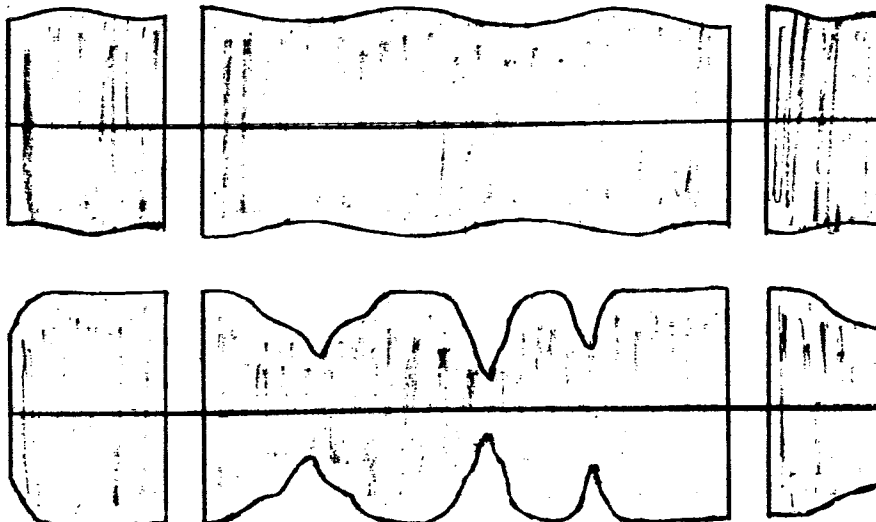
- F) The first sketch indicates a good surface, only minor dips will be observed in a revolution.
- G) The second sketch indicates that the surface is dirty and has started scoring the surface. The display on the scope will have sharp jagged decreases in amplitude. Where a good surface will have a minor and more gentle decrease and increase.
- H) This procedure should be repeated on all timing tracks (three) and on randomly selected data tracks.

This method will give you the general condition of the surface, however, if the diagnostic still gives error on a specific track and address this problem should be confirmed before replacing disk. Only a minor adjustment may be required to correct the problem.

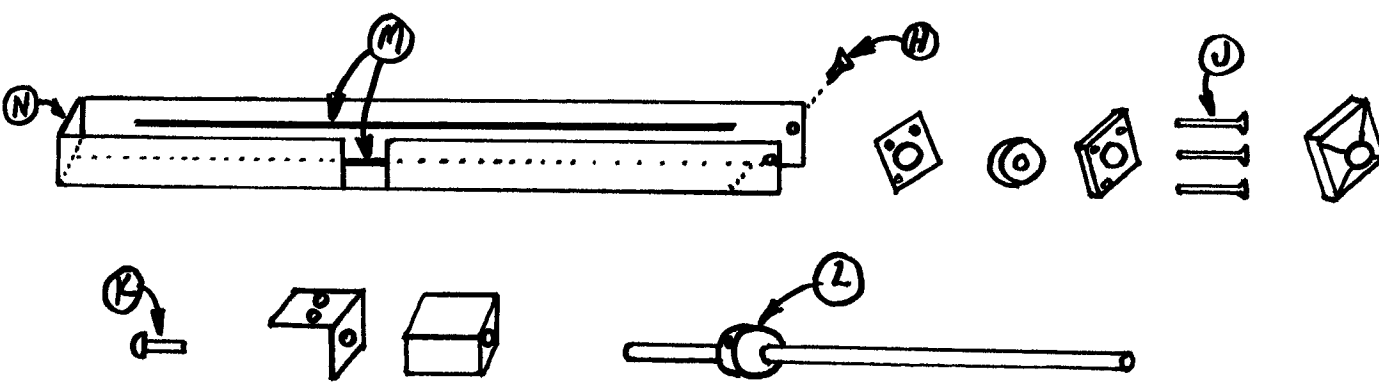
12. If bushing assembly is not loose and has not been binding, it should not be necessary to tamper with it. If binding is a problem then pry off the wood trim and by trial and error positioning of the bushing using the clamping screws (J) try to achieve smooth operation. The use of silicone or volume control cleaner is sometimes helpful.

11. Remove the remaining screw (H) from the bushing bracket (note when reassembling that this goes on the side opposite the wire cutout). Carefully pull the whole slide arm assembly out the end of the channel.

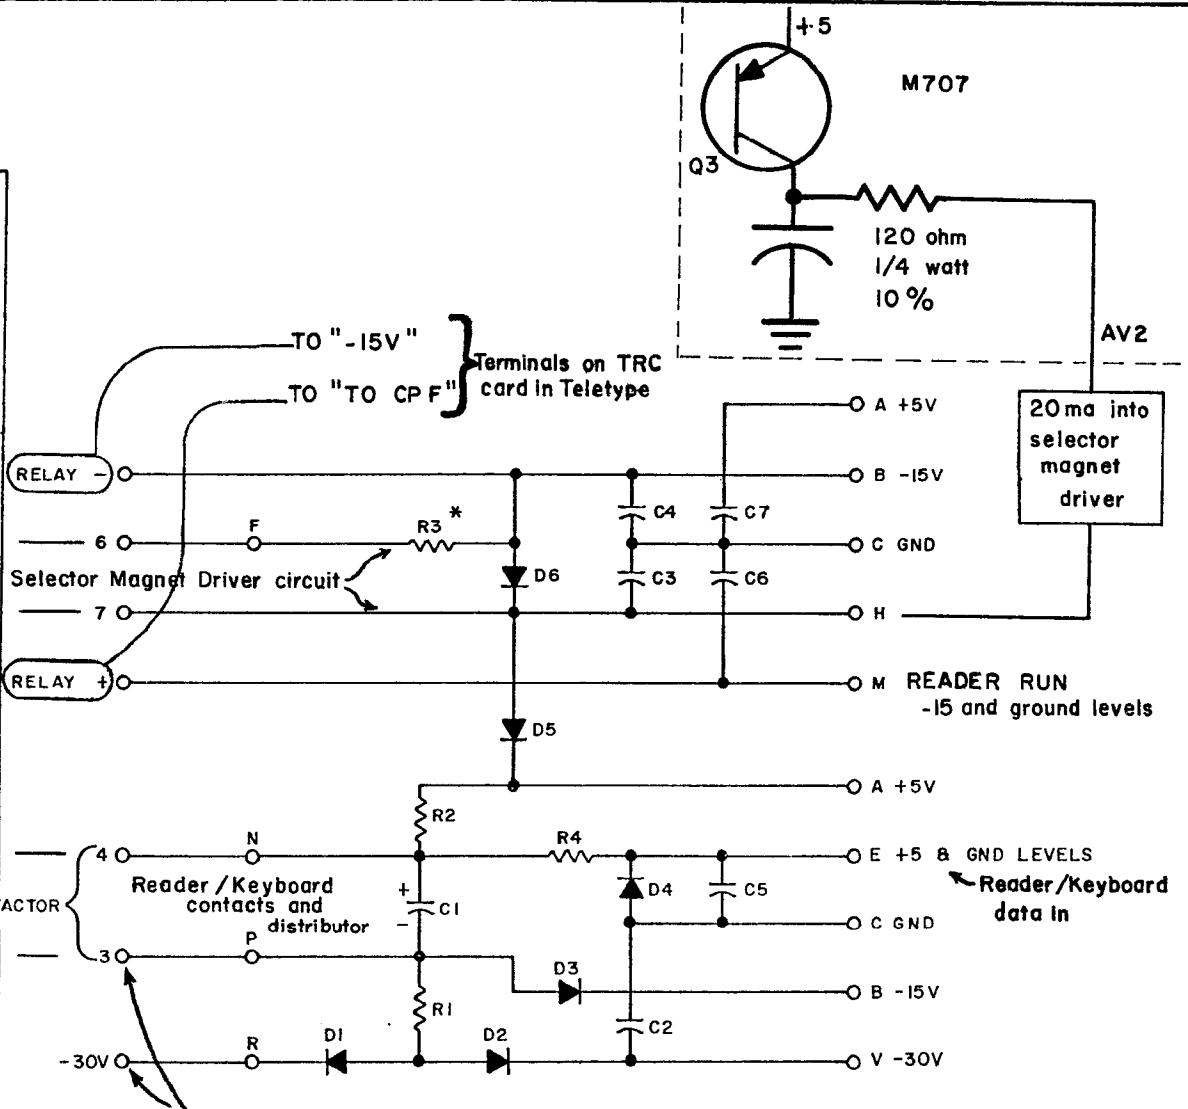
seven split lugs on W076
* R3 changed to 820 ohm 1/2 watt 20%

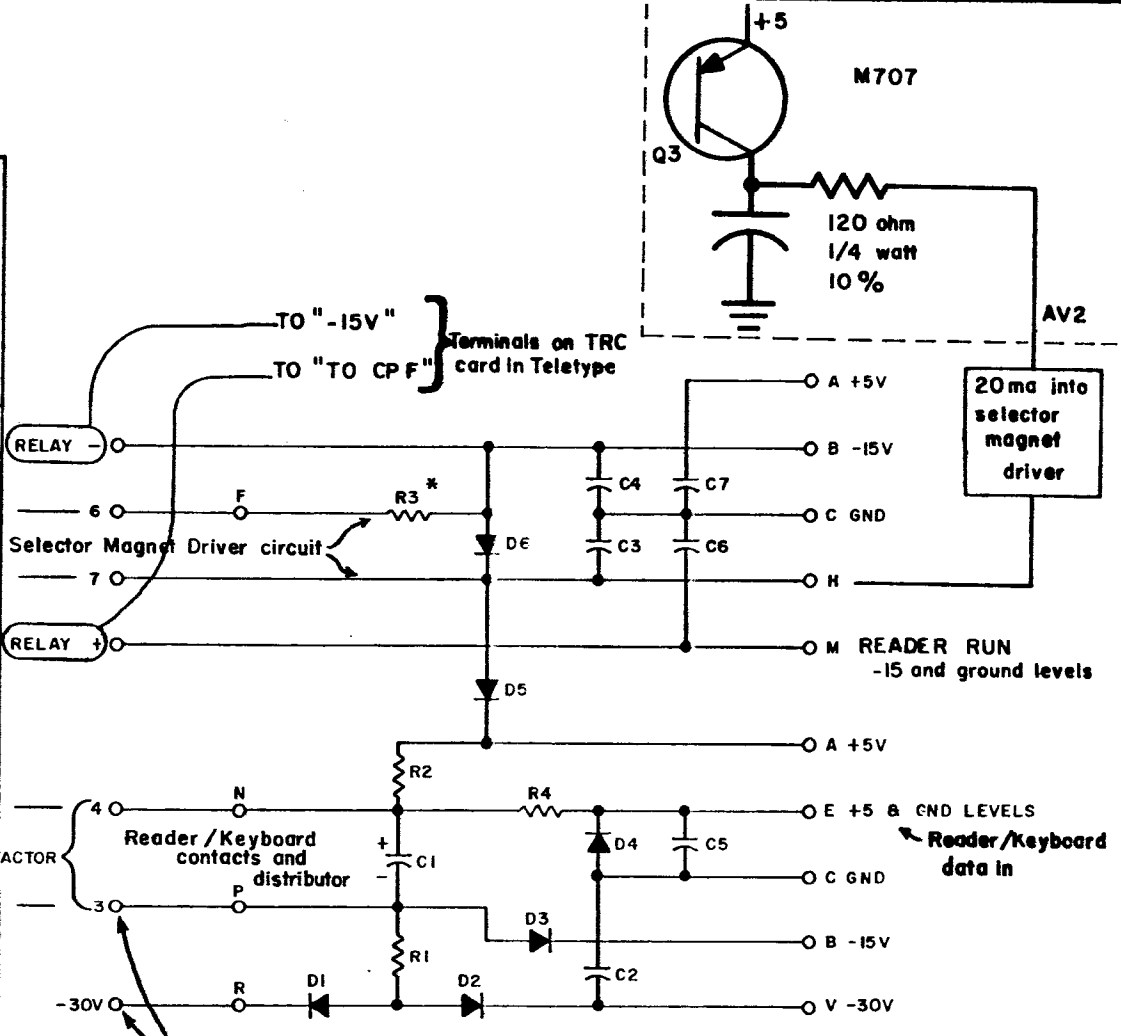
seven split lugs on W076
* R3 changed to 820 ohm 1/2 watt 20%

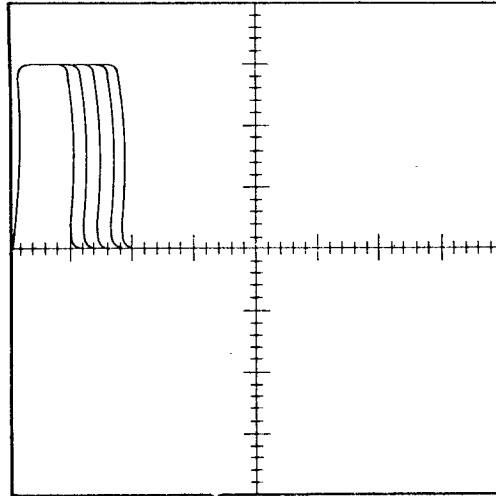
12-0126

NOTE: A RAGGED TRAILING EDGE
IS CAUSED BY TAPE BOUNCE

- e. Restore ac power to the computer and place the tape transport REMOTE/OFF/LOCAL switch to the LOCAL position. While observing the oscilloscope, move the master skew tape back and forth across the tape head. Note that the output of the skew checker (as presented on the scope) does not exceed $\pm 3 \mu\text{s}$. (Refer to Figure 4-18.)
- f. If the skew appears to be on the edge of the tape guides or slightly out of specification, some skew adjustment can be made by moving the tape head slightly to one side or the other and/or alternately loosening and retightening the mounting screws of the tape head clamps. In most cases, this action changes the skew $\pm 1 \mu\text{s}$. If a large amount of skew is present, shimming of the tape head becomes necessary.
